**Durability of all-composite civil engineering structures in  
service conditions. Development of an inspection and diagnosis  
system**

**André Miguel Pereira Castelo**

**Thesis approved in public session to obtain the PhD Degree in  
Civil Engineering**

**2023**

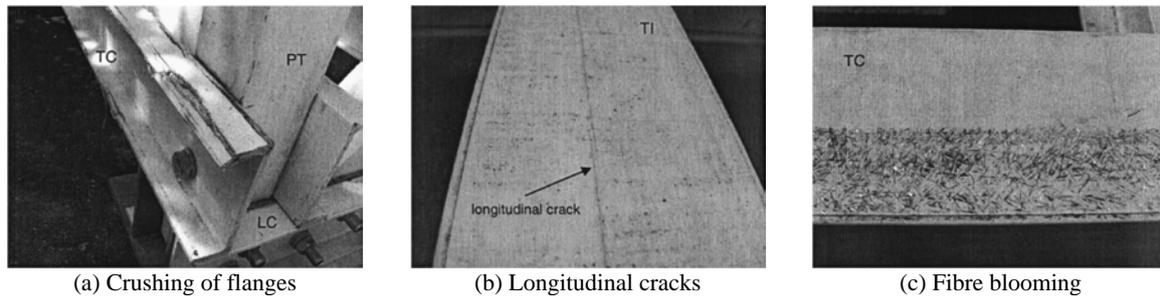
**Figure 4.02 - Examples of the anomalies detected in the Pontresina footbridge [II.14].**

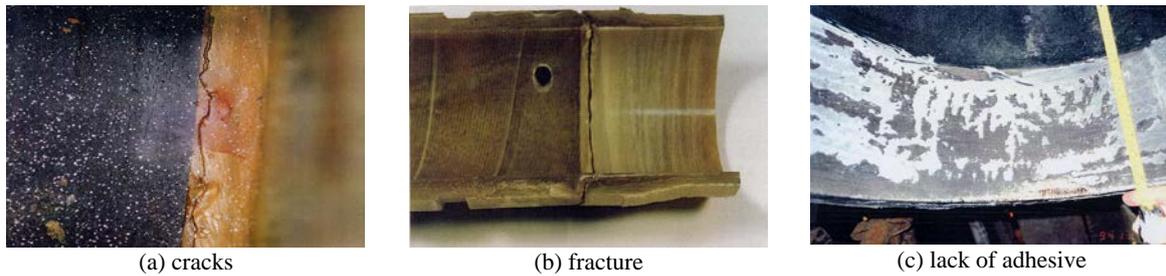
**Figure 4.04 - Examples of the anomalies presented in [II.15].**

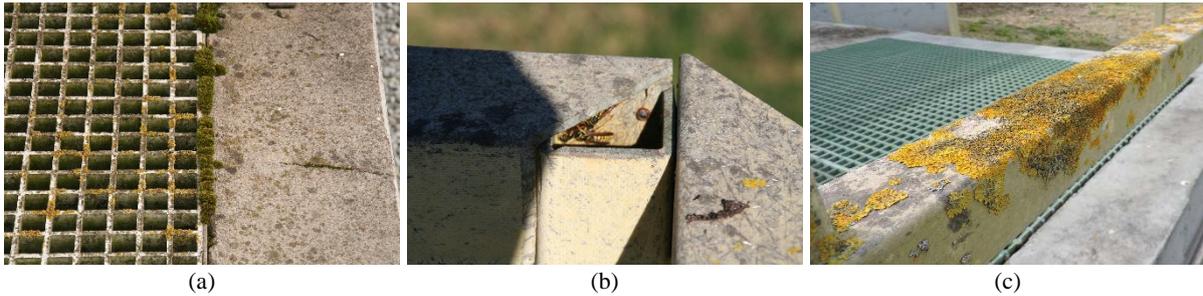
Figure 5.01 presents three examples of this anomaly: Figure 5.01(a) illustrates the moss growth at the edges of a moulded grating, mostly due to the accumulation of water and small debris in that area; Figure 5.01 (b) shows a nest of wasps inside a pultruded profile; and Figure 5.01(c) shows the development of lichens at the surface of a profile.

**Figure 5.01 - Examples of the A-N.Me.01 anomaly - biological colonization.**

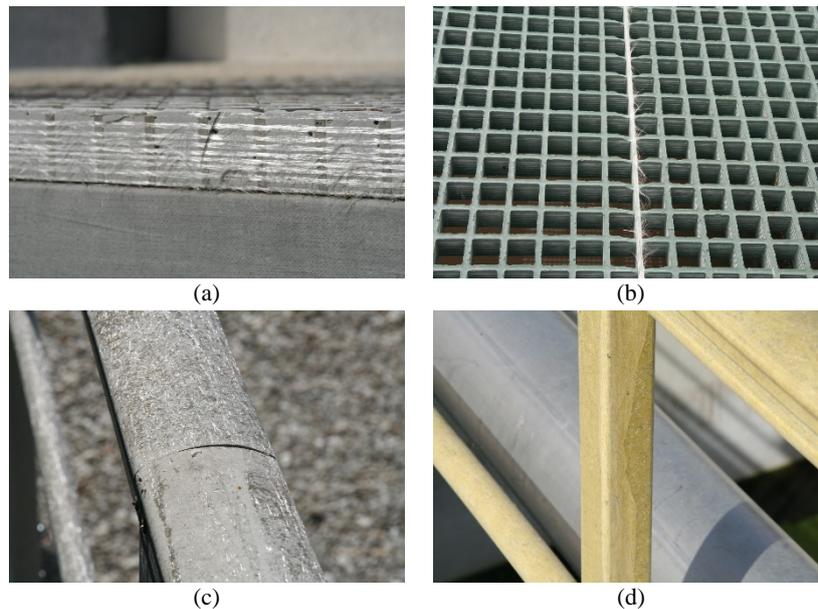
and Figure 5.03(d) shows fibre blooming along part of the section of a GFRP profile where the surface veil was misaligned during the production process.

**Figure 5.03 - Examples of the A-N.Me.03 anomaly - fibre blooming.**

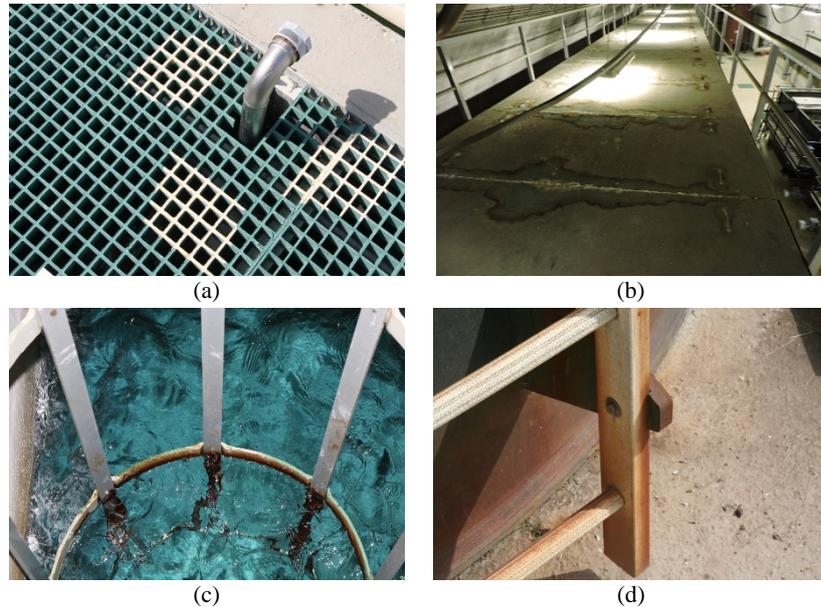
Figure 5.05 presents four examples of this anomaly: Figure 5.05(a) shows stains on a moulded grating resulting from accidental spills of paint; Figure 5.05(b) shows stains on the top surface of a closed moulded grating due to the continued deposition of chemical vapours; Figure 5.05(c) illustrates stains in the permanently wet region of a GFRP ladder; and Figure 5.05(d) shows stains on a GFRP ladder caused by an accidental iron oxide spill.

**Figure 5.05 - Examples of the A-N.Me.05 anomaly - stains.**

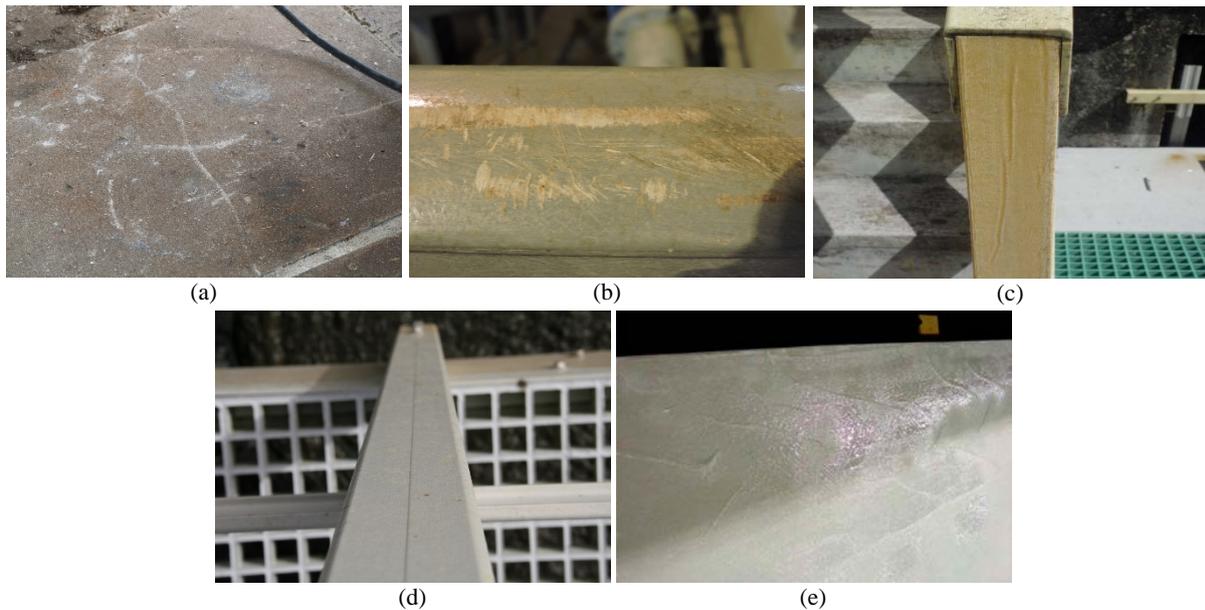
surface layer of a profile caused during the production stage.

**Figure 5.06 - Examples of the A-N.Me.06 anomaly - surface marks.**

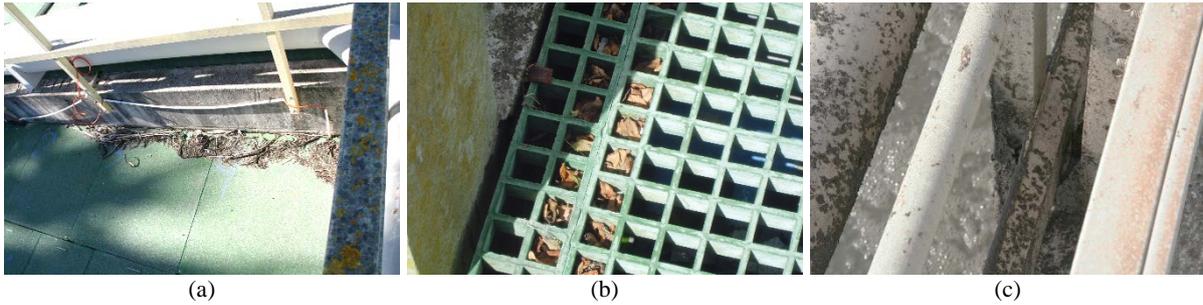
Figure 5.08 presents three examples of this anomaly: Figure 5.08(a) shows accumulation of debris on top a closed grating; Figure 5.08(b) illustrates accumulation of debris in the open spaces of a grating; and Figure 5.08(c) shows accumulation of debris by splattering on a profile of a handrail.

**Figure 5.08 - Examples of the A-N.Me.08 anomaly - debris accumulation.**

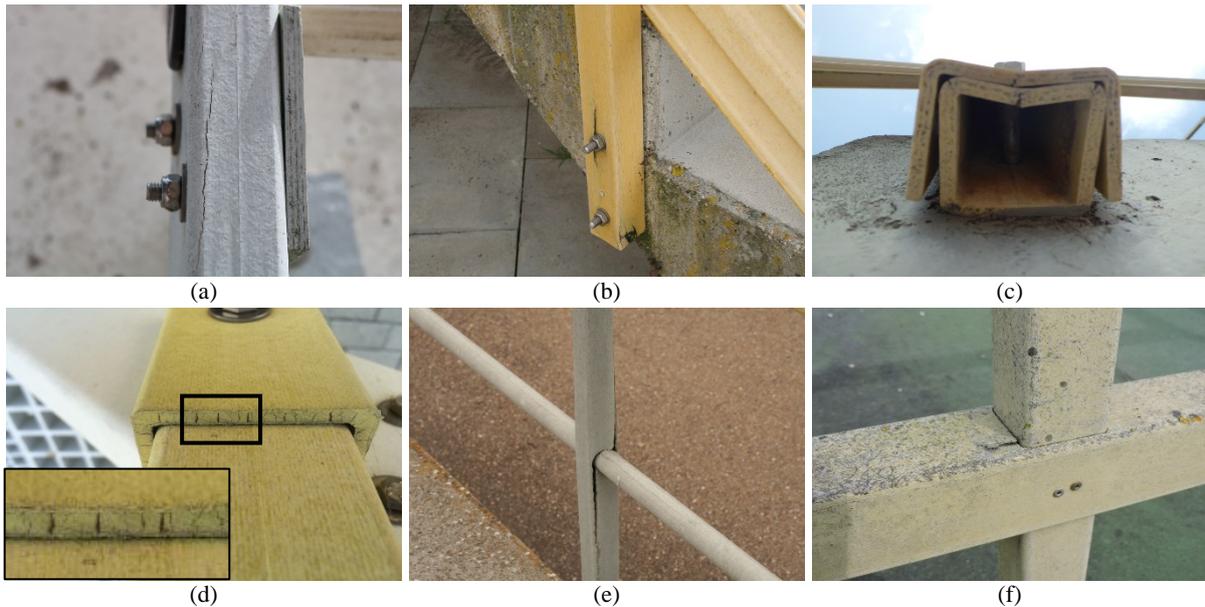
Figure 5.10 presents six examples of this anomaly: Figure 5.10(a) shows the cracking in a profile of a ladder, namely in a connection zone, due to bolts over-tightening; Figure 5.10(b) and (c) show the cracking in a connection zone between a profile and its fixing point, also due to bolts over-tightening, which caused excessive local transverse bending of the profiles' walls; Figure 5.10(d) shows the matrix cracking of some profiles, most likely due to lack of shrinkage additives at the production stage; Figure 5.10(e) and (f) show cracking between a vertical profile of a handrail, at the intersection with an horizontal profile. The cracking illustrated in Figure 5.10(e) is due to an accidental impact and incorrect detailing (the cross-section reduction of the vertical component at the joints seems largely excessive) and the crack depicted in Figure 5.10(f) occurred during the installation phase.

**Figure 5.10 - Examples of the A-Me.02 anomaly - cracking.**

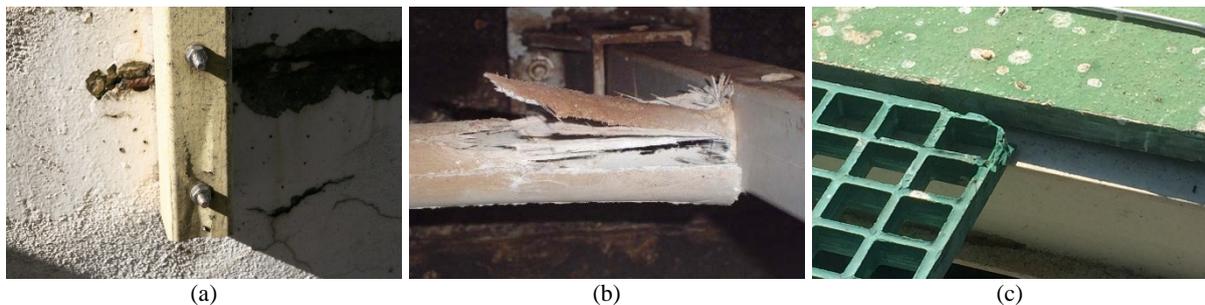
Figure 5.11 presents three examples of this anomaly: Figure 5.11(a) shows crushing of a connection zone between a profile and its fixing point, due to bolts over tightening; Figure 5.11(b) shows cracking of a connection zone between two profiles, due to an accidental impact; and Figure 5.11(c) shows crushing of a border of a grating, due to an accidental impact.

**Figure 5.11 - Examples of the A-Me.03 anomaly - crushing.**

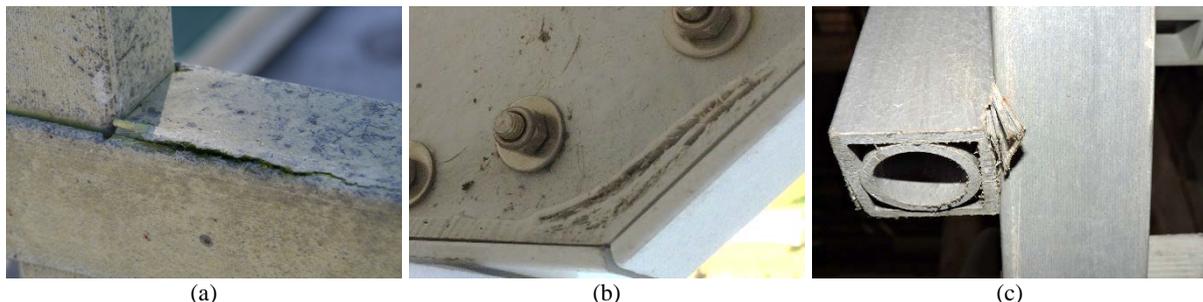
**Figure 5.13 - Examples of the A-Me.05 anomaly - delamination.**

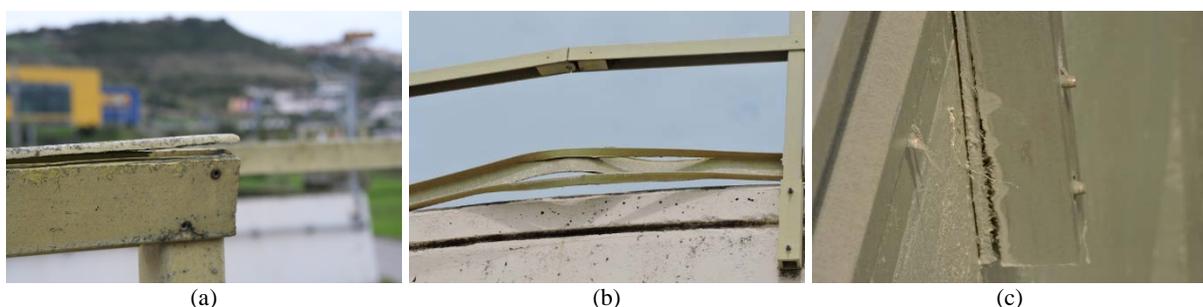
Figure 5.17 - Examples of the A-Me.12 anomaly - member failure.

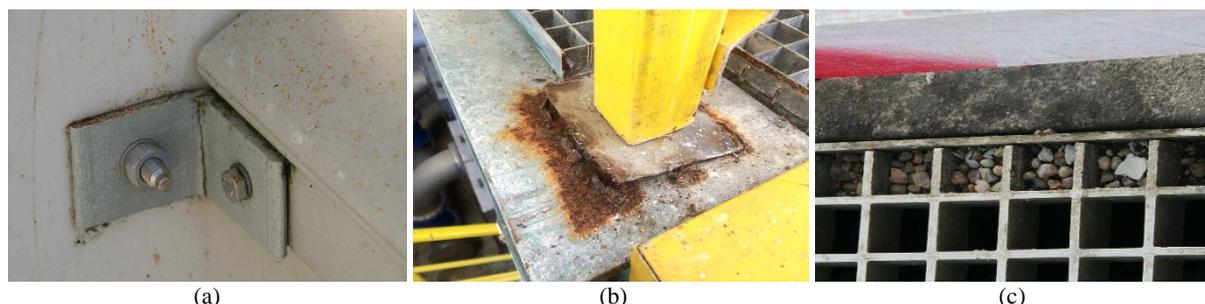
**Figure 5.20 - Examples of occurrence of anomalies due to causes of the design stage.**

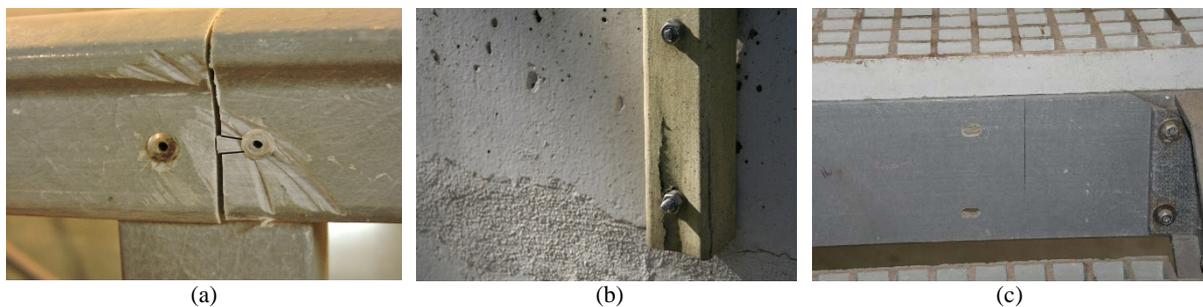
**Figure 5.21 - Examples of occurrence of anomalies due to causes of the installation stage.**
