**Durability of all-composite civil engineering structures in  
service conditions. Development of an inspection and diagnosis  
system**

**André Miguel Pereira Castelo**

**Thesis approved in public session to obtain the PhD Degree in  
Civil Engineering**

**2023**

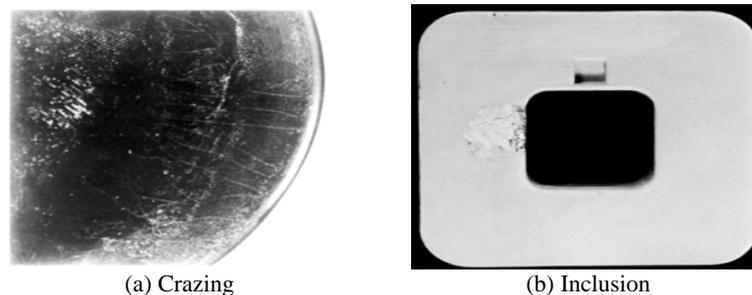
The above-mentioned ASTM standards [II.11]-[II.13] mention some of the anomalies that may occur at the production stage (presented in Table 4.01); even though each standard is specific a given type of manufacturing process, they all present a very similar list of anomalies that can be detected at the production stage. These standards specify some of the acceptance criteria upon fabrication for three different levels of product quality defined on the design of the product. Some examples of these anomalies are presented in Figure 4.01.

**Figure 4.01 - Examples of the anomalies presented in ASTM D2563-R02, adapted from [II.12].**

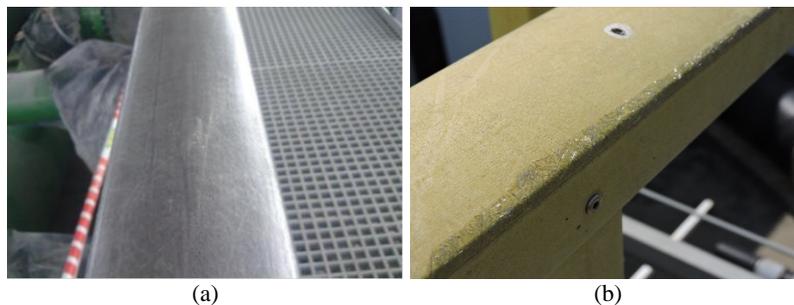
Figure 5.02 presents two examples of this anomaly. In both cases, the degradation was caused by exposure of the elements to the exterior environmental agents, namely rain and UV radiation.

**Figure 5.02 - Examples of the A-N.Me.02 anomaly - discolouration/loss of gloss.**

This anomaly can be avoided by using UV additives, including a surface veil in the fibre architecture (as shown in Figure 5.02 b) and/or applying a surface coating (e.g. paint, enamel or gel coating).

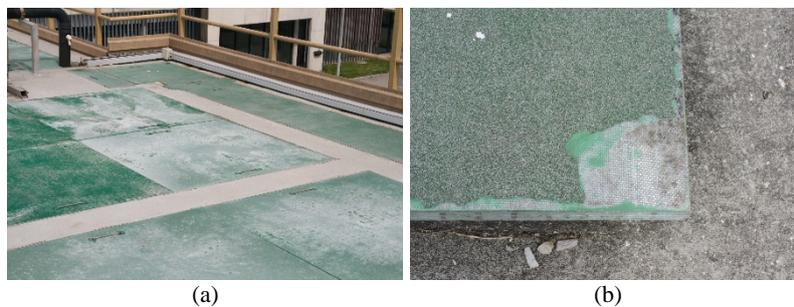
Figure 5.07 presents two examples of this anomaly: Figure 5.07(a) presents the degradation by surface wear during the transportation stage, while Figure 5.07(b) shows the loss of a portion of the protection layer of a closed moulded grating in one of its corners.

**Figure 5.07 - Examples of the A-N.Me.07 anomaly - wear damage.**

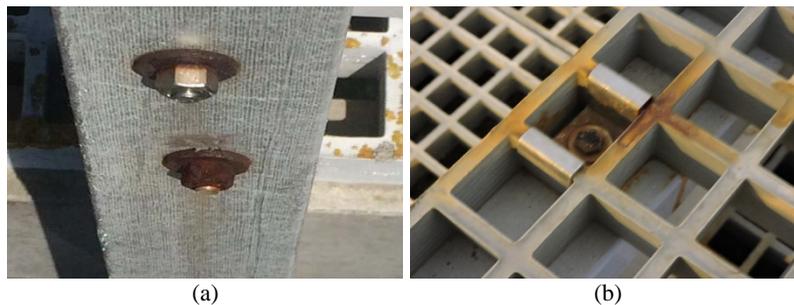
Figure 5.09 presents two examples of this anomaly: Figure 5.09(a) shows the corrosion of the metallic bolts and washers on a connection zone of a profile (bi-metallic corrosion); and Figure 5.09(b) illustrates the corrosion of metallic elements of a connection point of a moulded grating.

**Figure 5.09 - Examples of the A-Me.01 anomaly - corrosion of metallic components.**

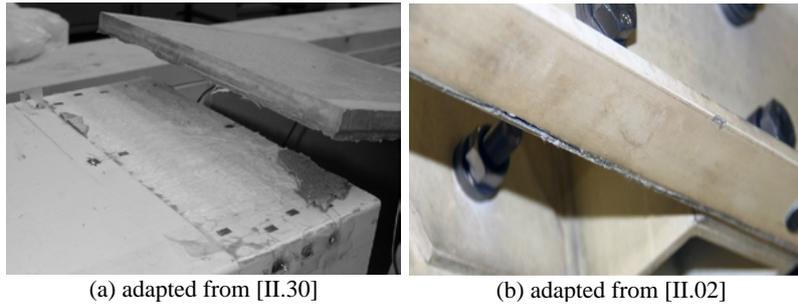
This anomaly consists of the detachment of two structural elements in a bonded connection. It is generally caused by a wrong choice/application of the adhesive or incorrect treatment of the surfaces of the elements to be bonded, in terms of roughness and cleaning. It can also be caused by incorrect design, namely excessive loading and/or deformation (as presented in Figure 5.12 (a)), as these connections are generally much stiffer than bolted ones. Figure 5.12 (b) presents the debonding between two profiles in the Pontresina Bridge, due to excessive bending of a GFRP adherend.

**Figure 5.12 - Examples of the A-Me.04 anomaly - debonding.**

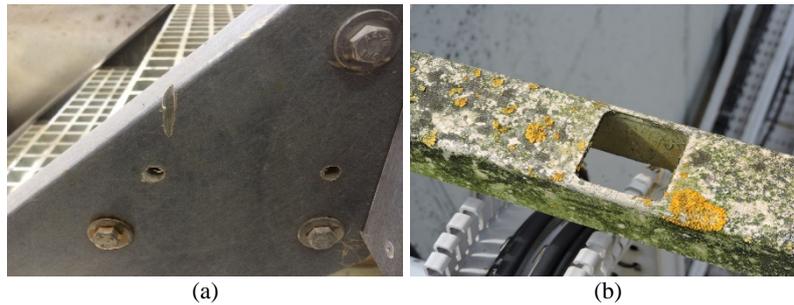
Figure 5.14 depicts two examples of this anomaly: Figure 5.14(a) shows the incorrect drilling

and cutting of a profile in a connection zone; and Figure 5.14(b) shows incorrect cutting of a profile in the middle of the element, with a very significant local reduction of stiffness and strength.

**Figure 5.14 - Examples of the A-Me.07 anomaly - geometrical imperfections.**

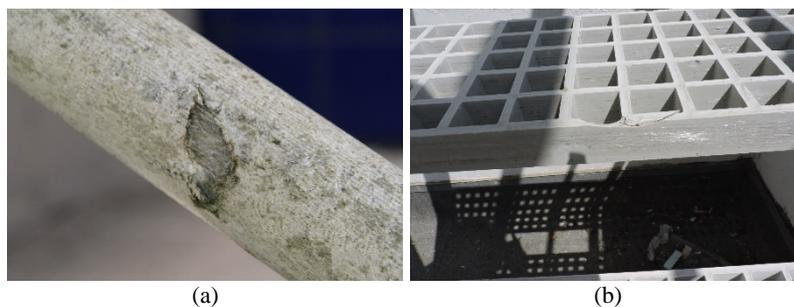
This anomaly consists of a partial or total indentation (perforation) of one or more surfaces of a pultruded profile or a grating by an external element. Figure 5.15 presents two examples of this anomaly: Figure 5.15(a) shows the indentation of a profile and Figure 5.15(b) shows the indentation of a grating.

**Figure 5.15 - Examples of the A-Me.08 anomaly - indentation/perforation.**

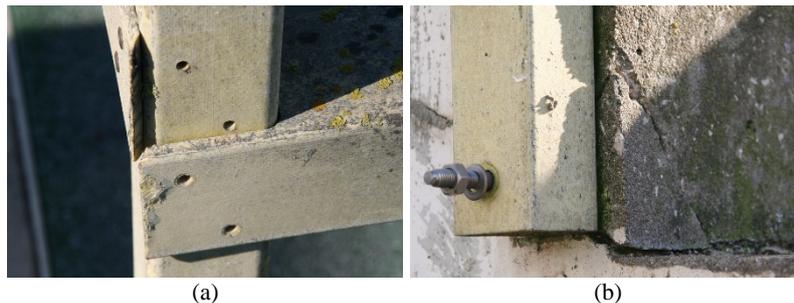
This anomaly consists of bolted connections in which there are missing components (e.g. nuts or washers) or in which they were loosely applied (e.g. with insufficient tightening) or not retightened during maintenance operations. It can lead to lower structural performance of bolted connections, in terms of strength and stiffness, and may eventually lead to other anomalies (e.g. indentation due to the absence of washers). Figure 5.16 presents two examples of this anomaly: Figure 5.16(a) shows (several) missing metallic elements in a bolted connection, while Figure 5.16(b) illustrates a connection with an under tightened nut (actually, it is completely loose).

Figure 5.16 - Examples of the A-Me.11 anomaly - loose connections.

In the connection between profiles, the most common anomalies are cracking (Figure 5.10(f)) and loose connections (Figure 5.16(a)); therefore, the constructive technique applied should avoid the occurrence of such anomalies.

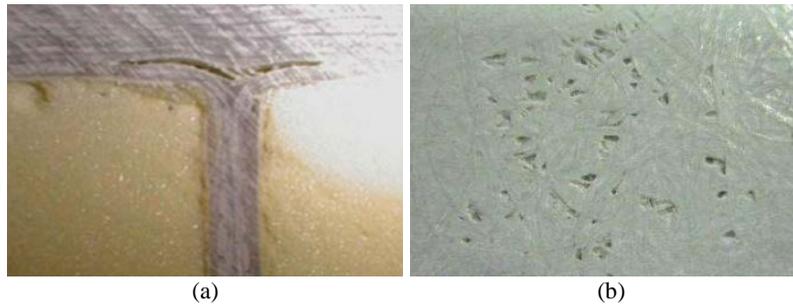
This anomaly consists of the appearance of voids (air pockets) inside the GFRP material or the adhesive used in bonded connections. This anomaly can only occur at the production stage. Figure 5.18

presents two examples of this anomaly: Figure 5.16(a) shows voids inside a profile (that would likely evolve to delamination), and Figure 5.16 (b) shows a superficial void on a profile.

Figure 5.18 - Examples of the A-Me.11 anomaly - voids.

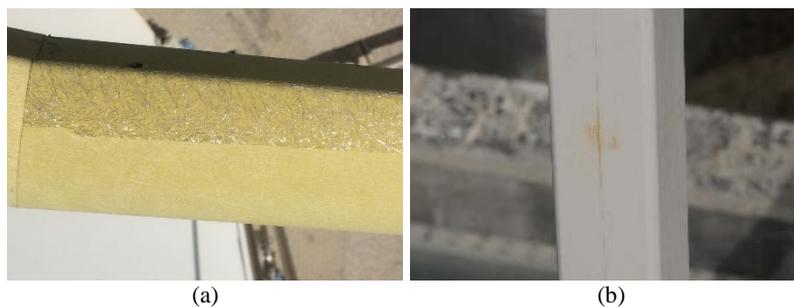
Figure 5.19 presents two examples of anomalies that occur due to causes of the production stage. Figure 5.19(a) shows the occurrence of the fibre blooming anomaly due to a misalignment of the superficial protection layer at the production stage (C.P.06). Figure 5.19(b) shows the occurrence of superficial marks on the entire section of the pultruded profile due to the misalignment of the die metallic parts at the production stage (C.P.07).

**Figure 5.19 - Examples of occurrence of anomalies due to causes of the production stage.**

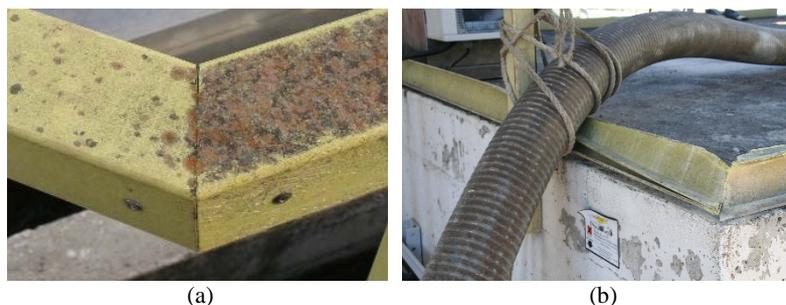
**Figure 5.22 - Examples of occurrence of anomalies due to causes of the in-service stage.**

Figure 5.22 presents two examples of anomalies that occur due to causes of the in-service stage. Figure 5.22 (a) shows the occurrence of biological colonization, loss of gloss and fibre blooming - these three anomalies are related with the exposure of the material to environmental conditions: rain (C.S.01) and UV radiation (C.S.02). Figure 5.22 (b) shows a member failure of a profile due to inadequate use (C.S.05).

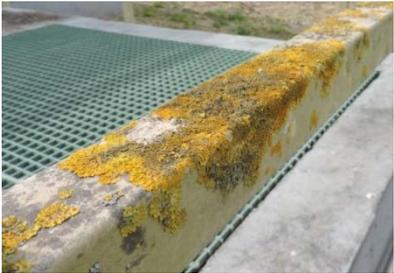
<b>ANOMALY FORM - A.N-ME.01</b>	
<b>ANOMALY NAME</b>

Biological colonization	
<b>ANOMALY DESCRIPTION</b>	
Biological colonization consists of biological matter on the surface of GFRP elements. This anomaly usually occurs in zones with high humidity/permanently wet environmental conditions.	
<b>POSSIBLE CAUSES</b>

- High humidity environmental condition (C.S.01)	- Lack of maintenance (C.S.06)
- Permanently wet environmental condition (C.S.01)	
<b>POSSIBLE CONSEQUENCES</b>

- Aesthetical appearance	- Reduction of mechanical properties (due to moisture exposure)
- Increase of water retention	
<b>DETAILS TO INSPECT</b>	
- Affected area	- Exposure to UV radiation

<b>SEVERITY LEVEL / REPAIR EMERGENCY</b>	
0 - Small biological colonization ( $A_f < 20\%$ )	
1 - High biological colonization ( $A_f > 20\%$ ) and/or high aesthetical significance of the element

- Application of superficial coating (water repellent coating) (R.03)	- Superficial cleaning (R.04)
<b>CLASSIFICATION PARAMETERS</b>	
- Conditions for progression of the anomaly (Y/N)	- Aesthetical significance of the element
<p>- Superficial area affected (<math>A_f</math> (%)) = <math>100 \times \text{Area with biological colonization/superficial and outer exposed area of 1 meter of profile} \times 100</math></p> <p>The considered superficial and outer exposed area is suggested in the diagrams below, for some of the most common types of profiles. The highlighted areas are the most commonly exposed areas to solar radiation on a horizontal profile, as such, the most probable area to the occurrence of biological colonization.</p>

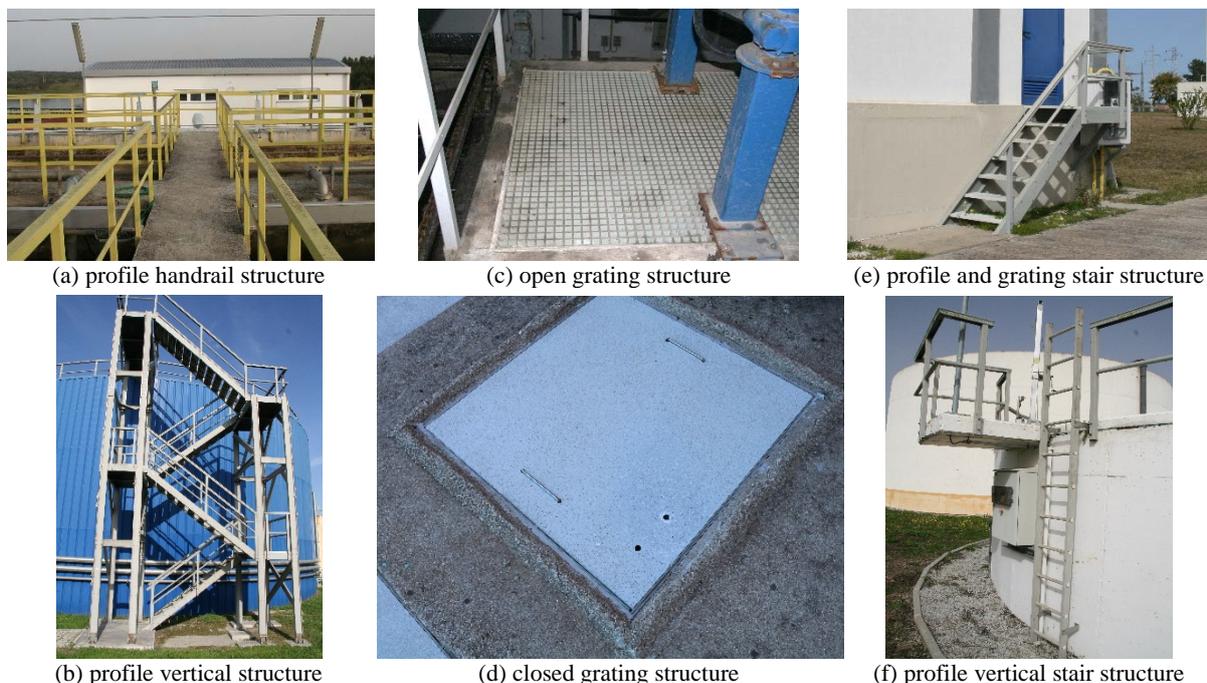
**Figure 9.01 - Types of structures considered.**

These substructures were categorized in three types of structures: profiles, gratings and stairs. As the name indicates, profile structures were made only of pultruded profiles (Figure 9.01 (a-b)) and gratings structures were made only of moulded gratings (Figure 9.01 (c-d)). However, the stair structures were considered to be a particular type of structure, in terms of materials (some were made only of profiles (Figure 9.01 (f)), and others had a combination of profiles and gratings (Figure 9.01 (e))) and in terms of constructive techniques (type of fixtures and connections), so these structures were studied separately, in order to better interpret the data gathered.

In stair constructions that require an extension of the vertical profile without connection to the support, as shown in Figure 9.01 (f), the type of reinforcing structure, presented in Figure 9.21 (f), should be applied in order to reduce the deflection of these extensions and consequent occurrence of anomalies at the connection points. The application of this type of reinforcement besides increasing the stability of the structure also increases the safety of end-users.

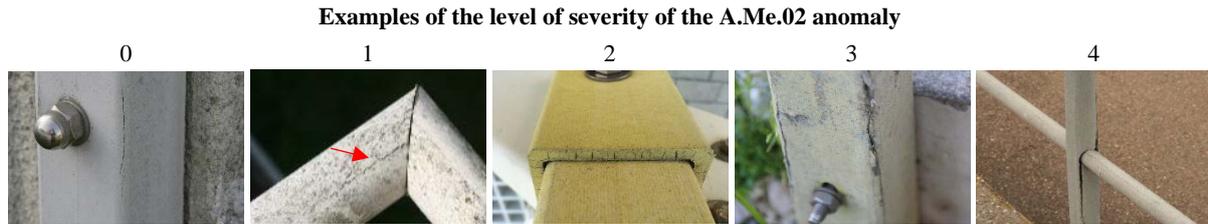
**Figure 9.11 - Severity levels of anomaly A.Me.02.**

With those parameters, the anomaly **A.Me.02** can be categorized in the following five severity levels: 0 - crack width lower than 0.5 mm with no conditions for progression and low aesthetical significance of the element; 1 - crack width lower than 0.5 mm with no conditions for progression and high aesthetical significance of the element; 2 - mapped cracking; crack width lower than 0.5 mm with conditions for progression; 3 - crack width higher than 0.5 mm with no conditions for progression; 4 - crack width higher than 0.5 mm with conditions for progression. Figure 9.11 presents an example of each of the severity levels of anomaly **A.Me.02**.

In total, anomaly **A.Me.02** was detected 99 times, with the following distribution of severity

levels: 15% in level 0, 33% in level 1, 31% in level 2, 8% in level 3 and 12% in level 4.

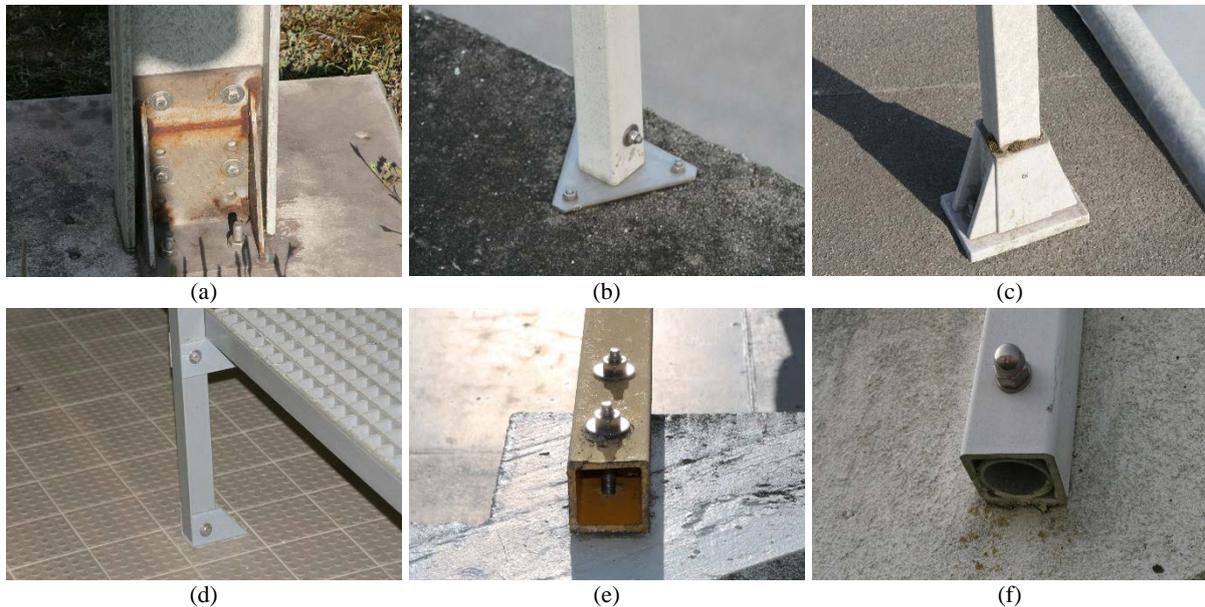
**Figure 9.18 - Examples of the most common connections of profile constructions and the support.**

When analysing the profile constructions, there are several areas that are more sensible and prone to the occurrence of anomalies. One of these areas is the connection between the profiles and the supporting element, Figure 9.18 presents some examples of the most common types of connections. These connections were usually with metallic elements (Figure 9.18 (a, b)), plastic elements (Figure 9.18 (c, d)) and more prominently with bolted fixtures (Figure 9.18 (d) and (e)).

The connections with plastic elements were more uncommon. The ones presented in Figure 9.18 (c) were in good state and had a high stiffness. Whereas, the connections presented in Figure 9.18 (d) were made with adapted sections of current pultruded profile sections, had a lower stiffness and were sometimes cracked, if not broken, between the web and flanges of the connection profile (Figure 5.20 (a)).

The bolted connections to the support (the most common type of connection inspected on profiles) is considered suitable for these types of constructions (Figure 9.18 (e)). However, as mentioned before, it is common to find cracks in these connections due to an overtightening of the bolts during the installation (Figure 5.10 (b)). This problem can usually be resolved with the increase of stiffness provided by adding a secondary profile outside (Figure 5.10 (c)) or inside (the most adequate solution - Figure 9.18 (f)) the main profile.

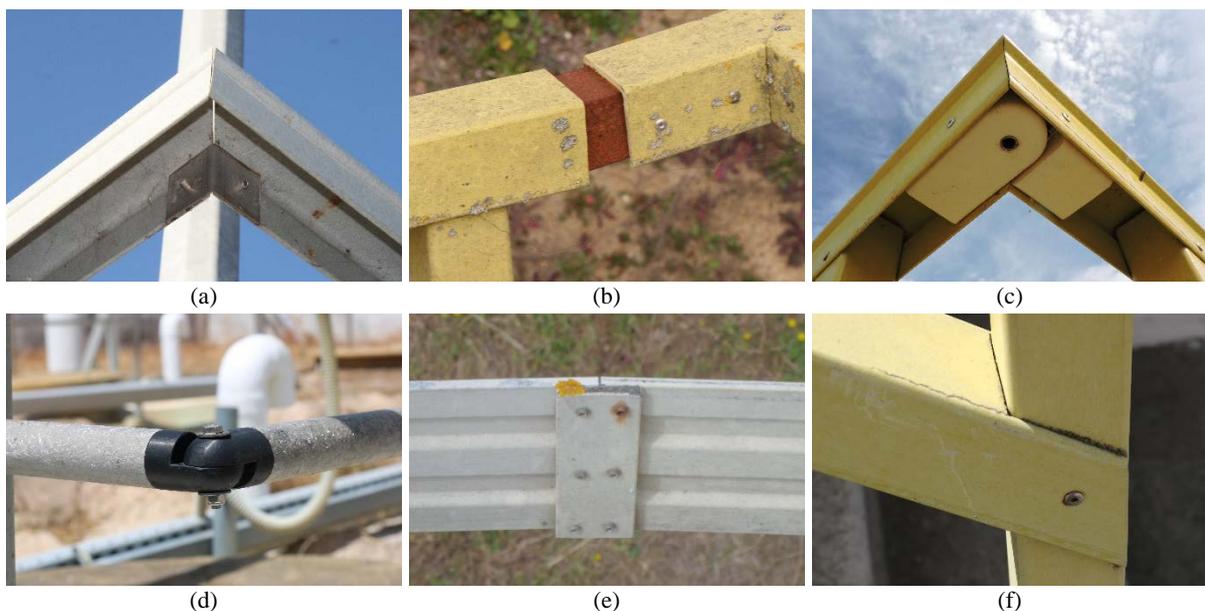
**Figure 9.19 - Examples of the most common connections between profiles.**

The connections between profiles with metallic elements (Figure 9.19 (a)) in accordance with was mentioned before present a higher stability. However, if the correct materials are not applied (e.g. stainless steel, aluminium), can present other anomalies such as corrosion (Figure 9.19 (b)).

The examples shown in Figure 9.19(c) for omega and c-shaped profiles and in Figure 9.19(d) for circular profiles are the best examples on how to connect these profiles, since they guarantee a certain level of flexibility to accidental impacts. Whereas, the example presented in Figure 9.19(e) using a small GFRP plate to connect the two profiles is sensitive to accidental impacts and often leads to failure of the connection by shear-out of the plate or the profile (Figure 5.21(a)). In the example presented in Figure 9.19(f) the section of a profile was cut so as to fit into the other profile. This type of connection between profiles was often used and frequently led to cracking (Figure 9.19(f)), delamination (Figure 5.13(a)) or section failure of the profile.

plastic element is used in the connection between profiles, as shown in (Figure 9.19 (c) to (f)). However, the use of plastic elements in these connections always require the use of complementary metal elements (e.g. bolts, rivets), these elements should also be of stainless steel in order to avoid their corrosion.

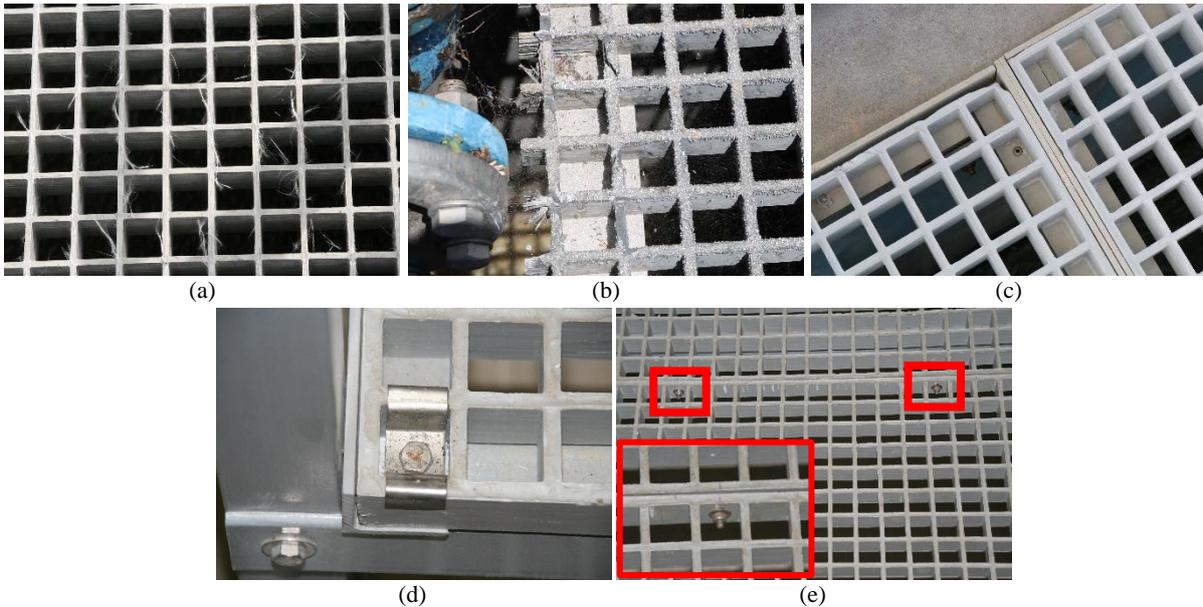
**Figure 9.20 - Examples of gratings constructions.**

During the fabrication process of a grating (moulded casting, see section 2.3.2) the top side of the mould is always more irregular and has thicker layer of resin. In outdoor applications, this side should always be put faced up in order to mitigate the occurrence of fibre blooming (Figure 9.20 (a)).

In these constructions one of the most sensitive areas are the edges of the grating. When the gratings are cut and left with live edges, these can be easily crushed during the life stage of the construction (Figure 9.20 (b)). One way to reduce the occurrence of this anomaly is to protect the border of the grating with an L-shaped profile (Figure 9.20 (c)).

When these constructions have larger spans and are only simply supported on opposing edges, there is usually an effect of excessive deflection mid-span of the unsupported edges. When the end-users are walking between a succession of these profiles, this excessive deflection between the edges can lead to a feeling of unsafety. This deflection can be mitigated by fixing the supported edges (Figure 9.20 (d)) in order to restrain their rotation and the gratings should be bolted together by the edges (Figure 9.20 (e)) in order to prevent the possible difference in deflection between the gratings and increase the overall stiffness of the construction.

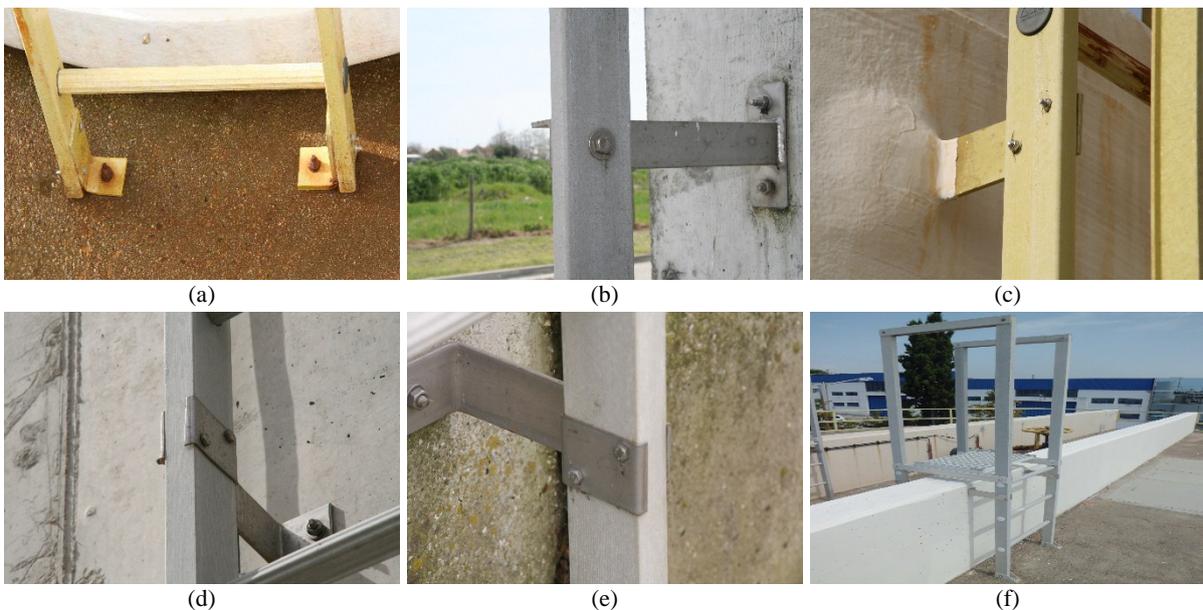
**Figure 9.21 - Examples of stair constructions.**

There are three primary anomalies in stair constructions that can be mitigated at a design stage: corrosion of metallic elements, cracking and excessive deflections. The corrosion of metallic elements (Figure 9.21 (a)) can be avoided by using stainless steel in all the fixtures necessary for these constructions.

The cracks and excessive deflections are related with the types of connections these constructions have to their support, since most of the anomalies detected are found at connection points. These connections can be made with metallic elements (Figure 9.21 (b)) or plastic/GFRP elements (Figure 9.21 (c)). The metallic connections present a higher stiffness in comparison to the plastic/GFRP connections and, as such, reduces the lateral deflection of the structure.

Most of the stair structures are installed vertically (as shown in Figure 8.01 (f), parallel to the wall). In these cases, the distance between fastenings is sometimes excessive and the stair structure has a low inertia to perpendicular movements. This may contribute to a higher occurrence of cracking in the vertical profiles

Also, at the connection points, there is an excessive tightening of the metallic bolts, leading to cracking of the vertical profiles, which have a thin wall cross-section. This anomaly can be mitigated with the application of a reinforcing metallic element (Figure 9.21 (d-e)).
